Enhanced Preliminary Assessment Report:

Orange Army Housing Units
Orange, Connecticut

October 1989

Environmental Research Division
Argonne National Laboratory
Argonne, Illinois 60439

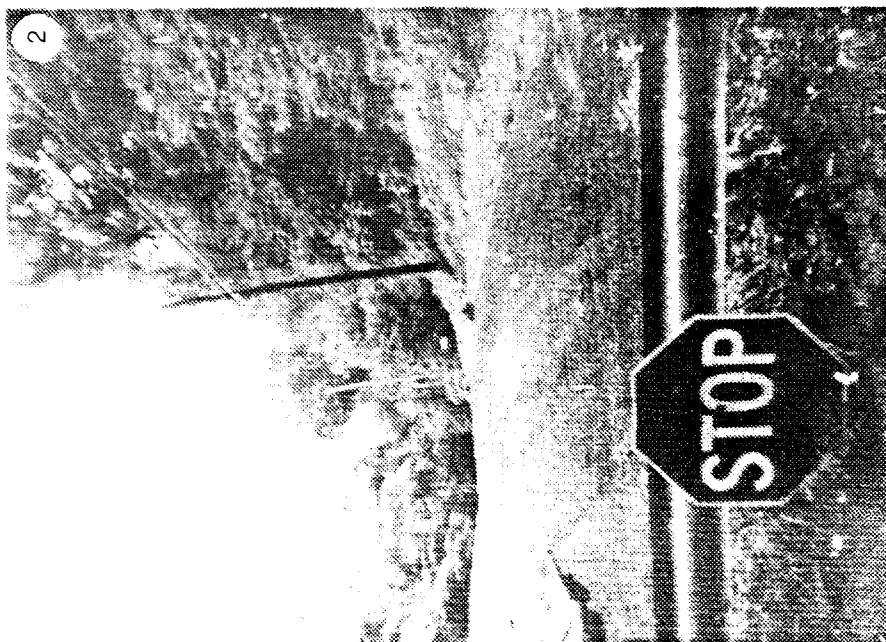
1. A view along Smith Farm Road from its intersection with Sybil Street; at top of road a barrier bars access to the site from Diana Road, which crosses Smith Farm Road beyond the barrier.

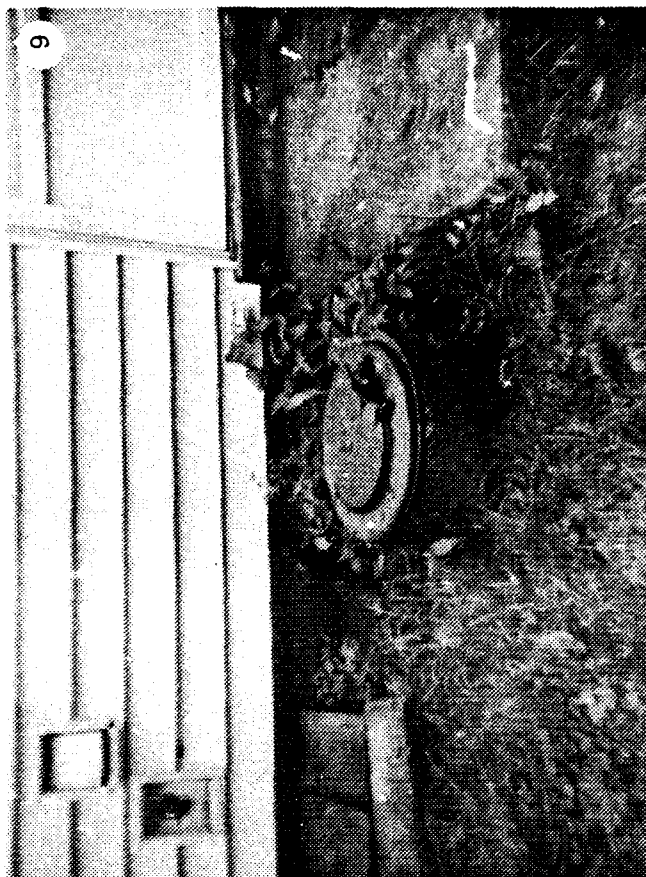
Potential risk to health might also attach to the collection of rainwater in the storage-tank containment box if the water is allowed to stagnate. On the other hand, if the occupant of a housing unit opens the containment-box drainage tap to release rainwater but forgets to close it, the effectiveness of the trough in containing an oil leak would be compromised should a tank rupture occur.

7. A closer view of the fuel-oil storage tank in photograph 6; the end seam of the tank shows considerable rusting.
8. The drainage tap of the concrete containment box; oil leaks from the tank would not be contained were this tap to be left in the open position.

A second potential environmental impact derives from the continued use of the inadequately protected above-ground fuel-oil storage tanks and their associated concrete containment boxes. The integrity of these relatively new storage tanks should be confirmed, and following treatment for existing rust, protective coatings should be applied to the exteriors of the tanks. With respect to containment-box drainage taps, a method should be devised to ensure that they do not remain in the open position for extended periods of time.

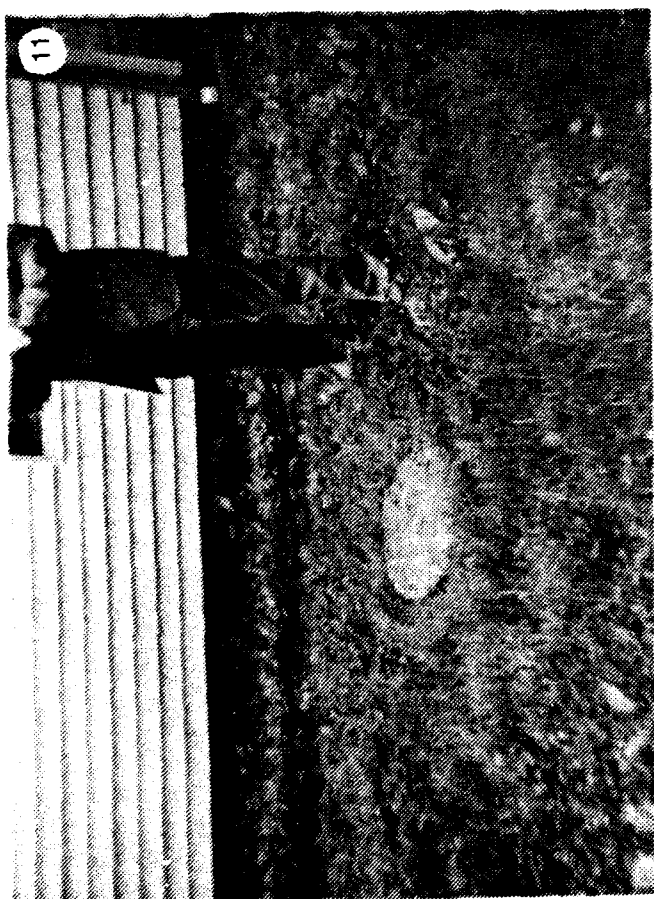
According to the Area Facilities Engineer in Windsor Locks, the septic systems are no longer adequate to service the units and do not meet existing State of Connecticut standards. Furthermore, the groundwater table is high, lying just below the surface, and contributes to and exacerbates septic system problems. The unit at 345 Sybil Street is now closed to occupancy because of backup of sewage caused by a leaching-trench plugging problem that persisted despite repeated attempts to correct it.

Similar sewage backup problems have been experienced at 345 Smith Farm Road. The Army Corps of Engineers is currently reconstructing the leach field serving that unit.

12. Sludge in the sewer system holding tank of unit #345.

The 20 putatively substandard waste-disposal systems represent a continuing potential for environmental impact and a possible impediment to the expeditious excessing of this property. It is therefore recommended that a determination be made of the adequacy of the waste-disposal systems and that whatever modifications deemed necessary to meet State of Connecticut standards be made.
